Manhole Inspection Summary

Manhole # S45I__035MH

Insp Date: **4/29/08 9:26 AM**

Location Address: **419 portugal st**

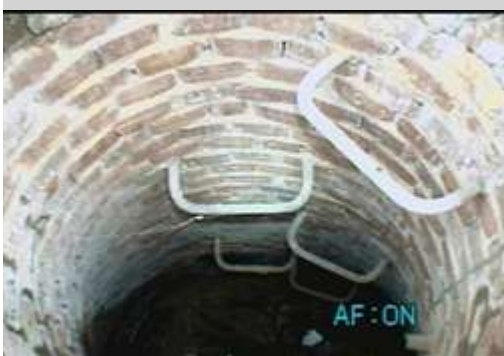
Miscellaneous

manhole steps

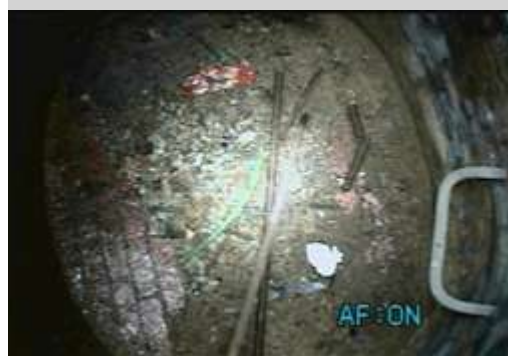
Defect 2

Condition: ☐ Sound ☐ Cracked ☐ Root Intrusion ☐ Deteriorated ☐ Leaks ☒ **Debris**

channel debris

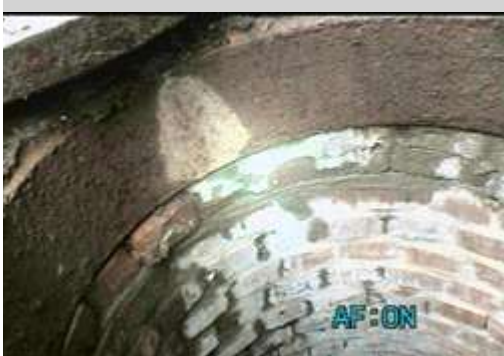
Defect 1

Condition: ☐ Sound ☐ Cracked ☐ Root Intrusion ☐ Loose Brick ☒ **Deteriorated**

Infiltration: ☐ None ☒ **Joint** ☐ Cracks ☐ Mortar ☐ Roots ☐ Wall

chimney deteriorated with infiltration from joint

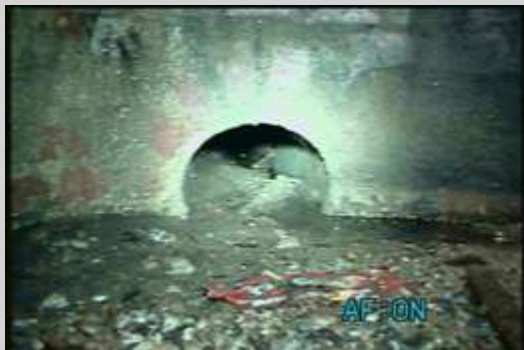
12 O'Clock Outflow

Deposits: ☐ None ☐ Mud ☐ Sludge ☒ **Debris** ☐ Grease

Silt Depth: **3** (in.) Deposits Extent: **Medium**
